(NASA-CR-135196) GRAPHITE FIBER REINFORCED  
THERMOPLASTIC RESINS Final Report (United  
Technologies Research Center) 74 p  
HC A04/MF A01

# Graphite Fiber Reinforced Thermoplastic Resins

United Technologies Research Center

Contract NAS3-20077

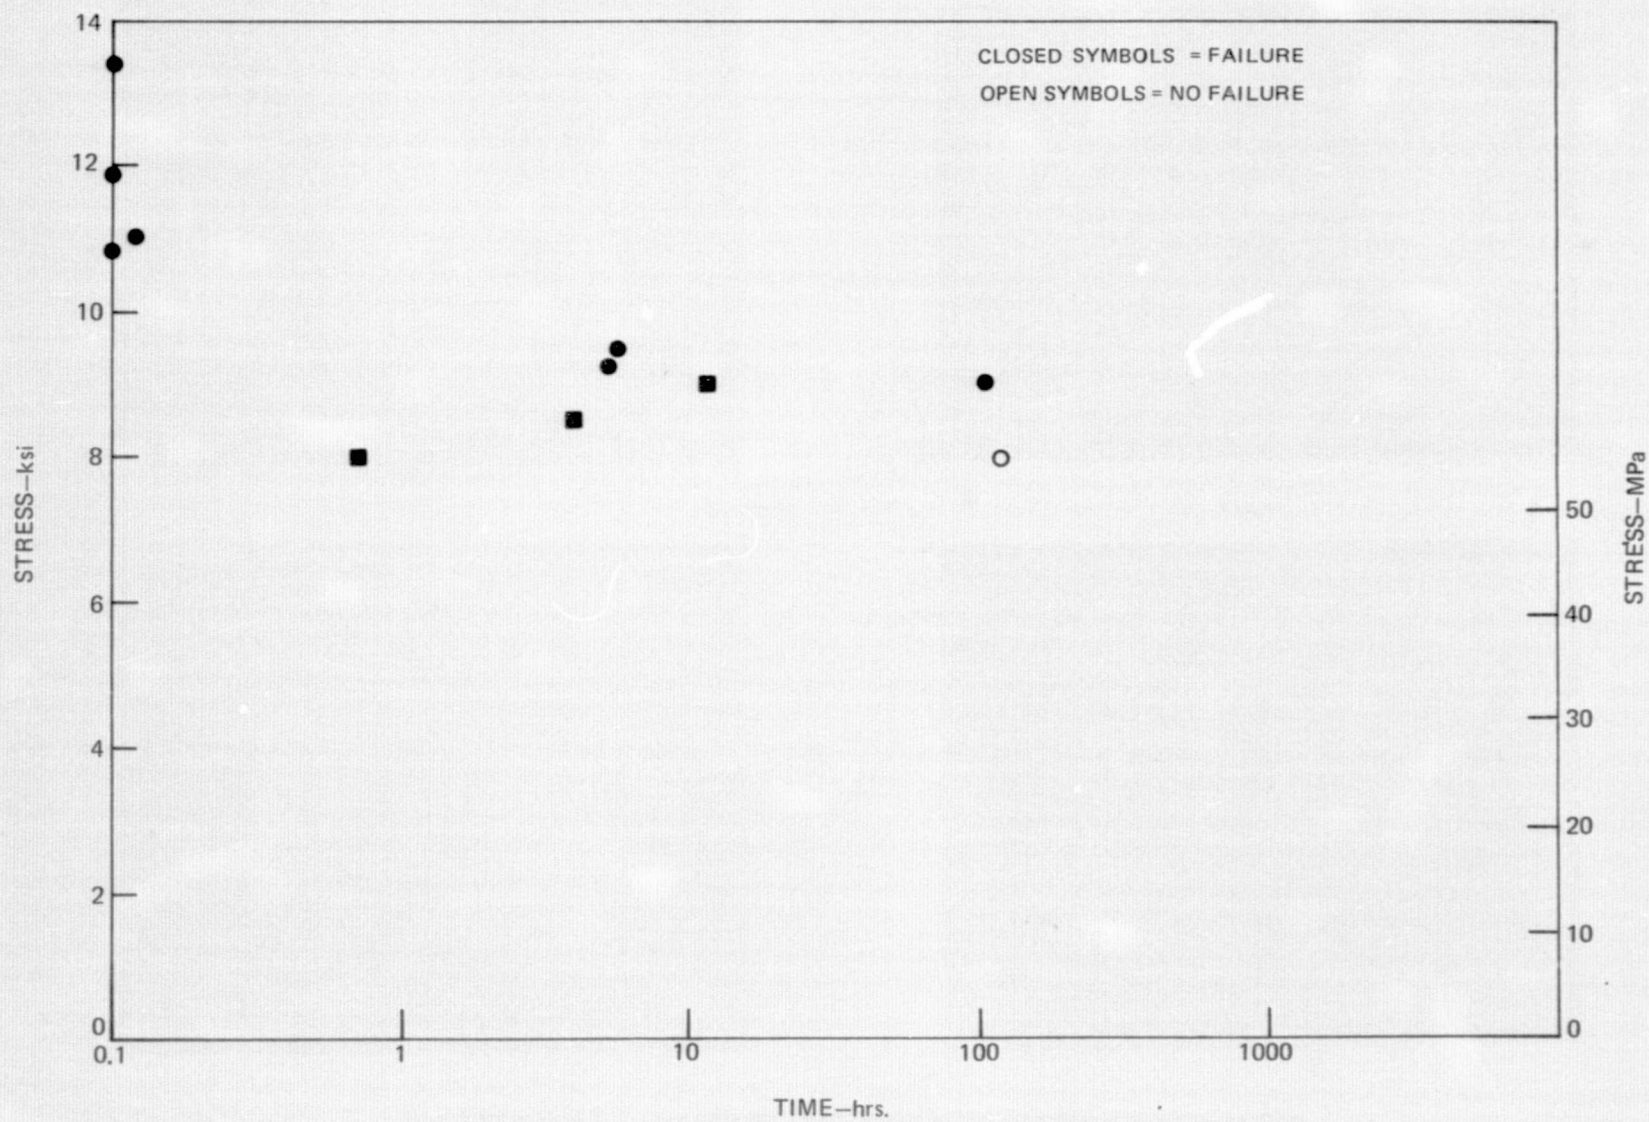
FIG. 23

# HMS/300P POLYETHERSULFONE STRESS-RUPTURE AT 177°C

± 45° ORIENTATION

Stress-rupture test results for the 149°C and 177°C conditions are given in Figs. 22 and 23, respectively. Although there was a large variation in the static tests at 149°C, the stress-rupture results were relatively consistent, and the data indicated a 100 hr stress limit of approximately 69 MPa (10 ksi) at that temperature. As shown in Fig. 23 the 100 hr stress at 177°C was 62 MPa (9 ksi) or nearly as high as the 149°C value. These results demonstrated a significantly higher upper use temperature for the 300P polyethersulfone than that which was found for the P-1700 polysulfone matrix composites.

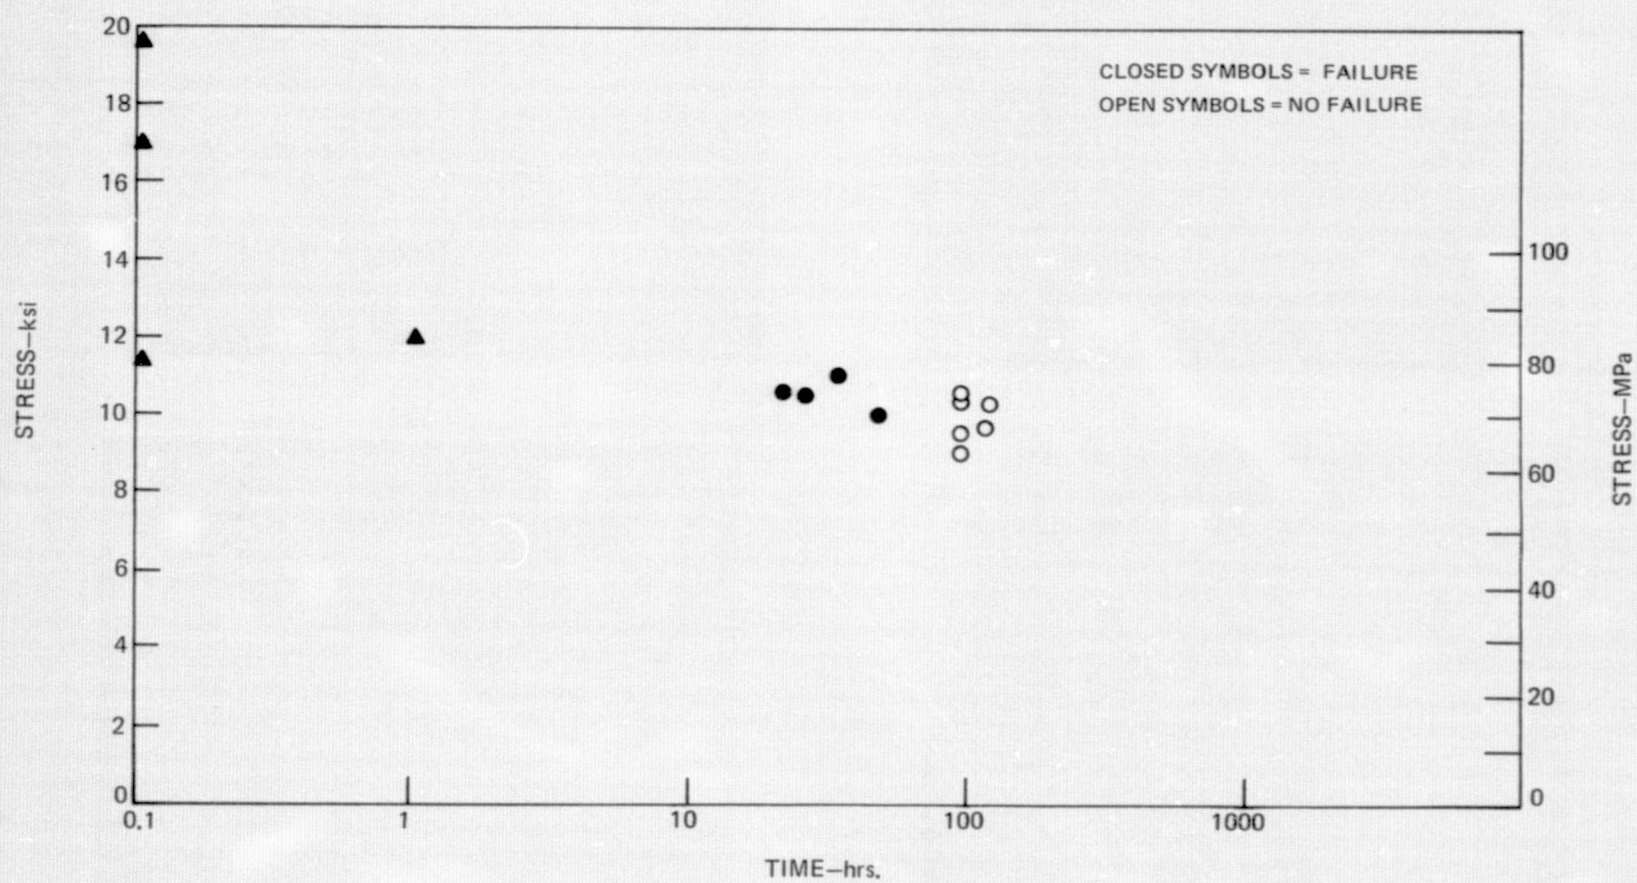
FIG. 22

## HMS/300P POLYETHERSULFONE STRESS-RUPTURE AT 149°C

$\pm 45^\circ$  ORIENTATION

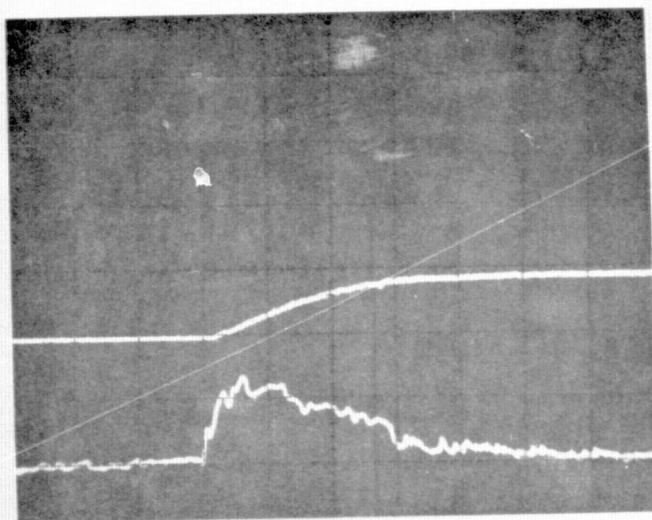
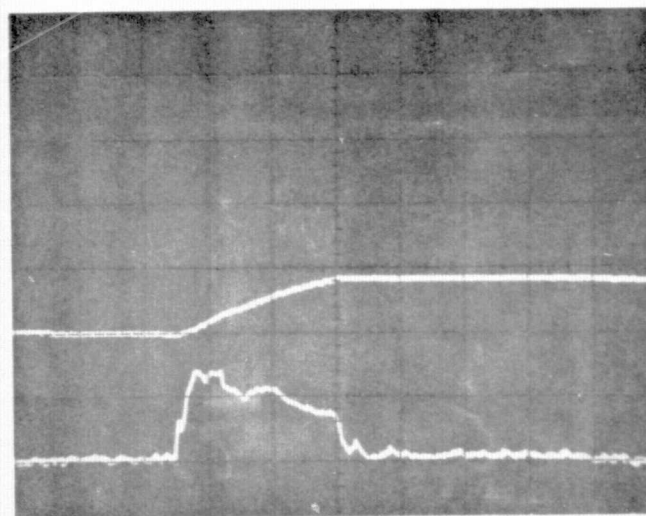
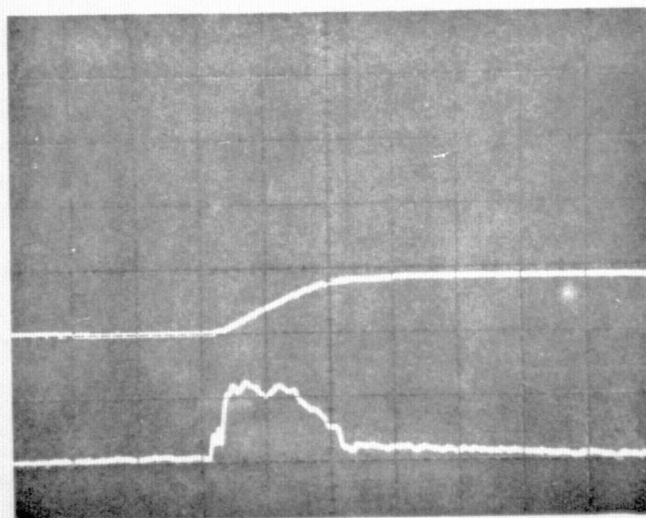
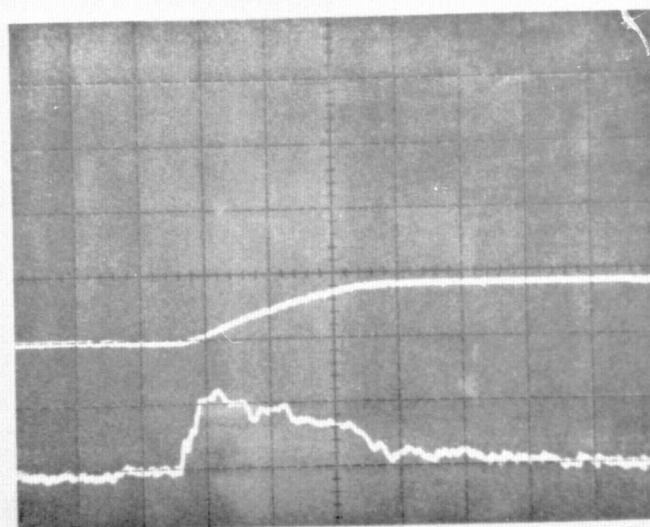
FIG. 24

# HMS/ASTREL 360 POLYARYLSULFONE THIN PENDULUM IMPACT TESTS

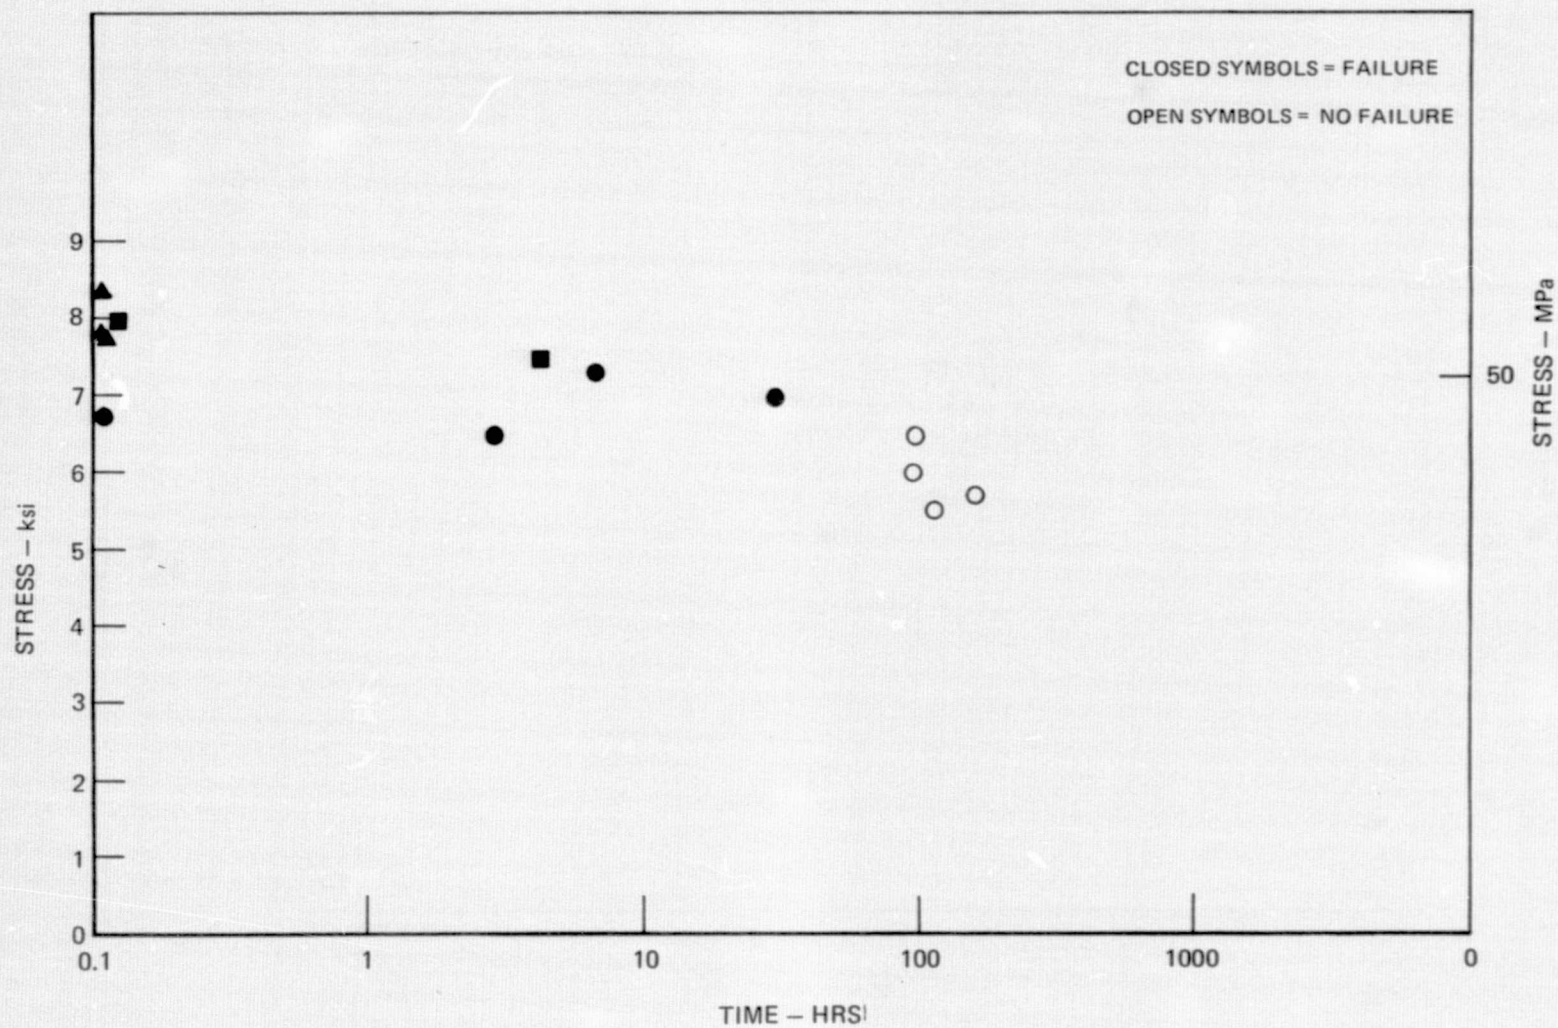
FIG. 25

## HMS/ASTREL 360 POLYARYLSULFONE STRESS-RUPTURE AT 177°C

$\pm 45^\circ$  ORIENTATION

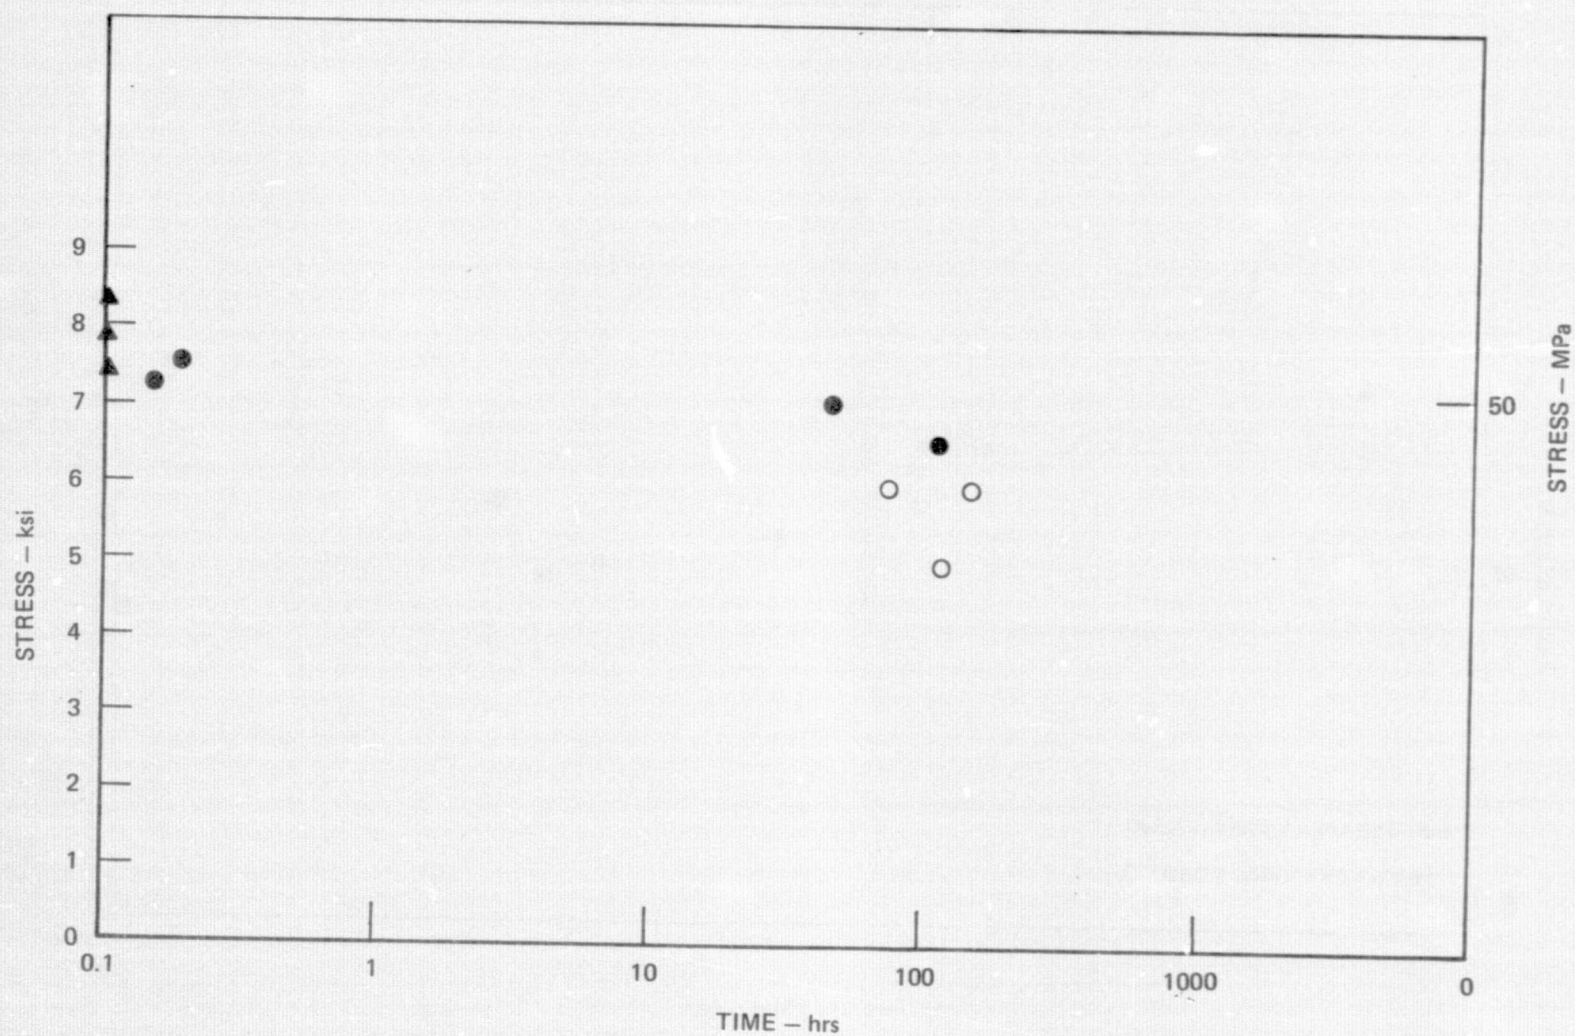
FIG. 26

## HMS/ASTREL 360 POLYARYLSULFONE STRESS-RUPTURE AT 204°C

$\pm 45^\circ$  ORIENTATION

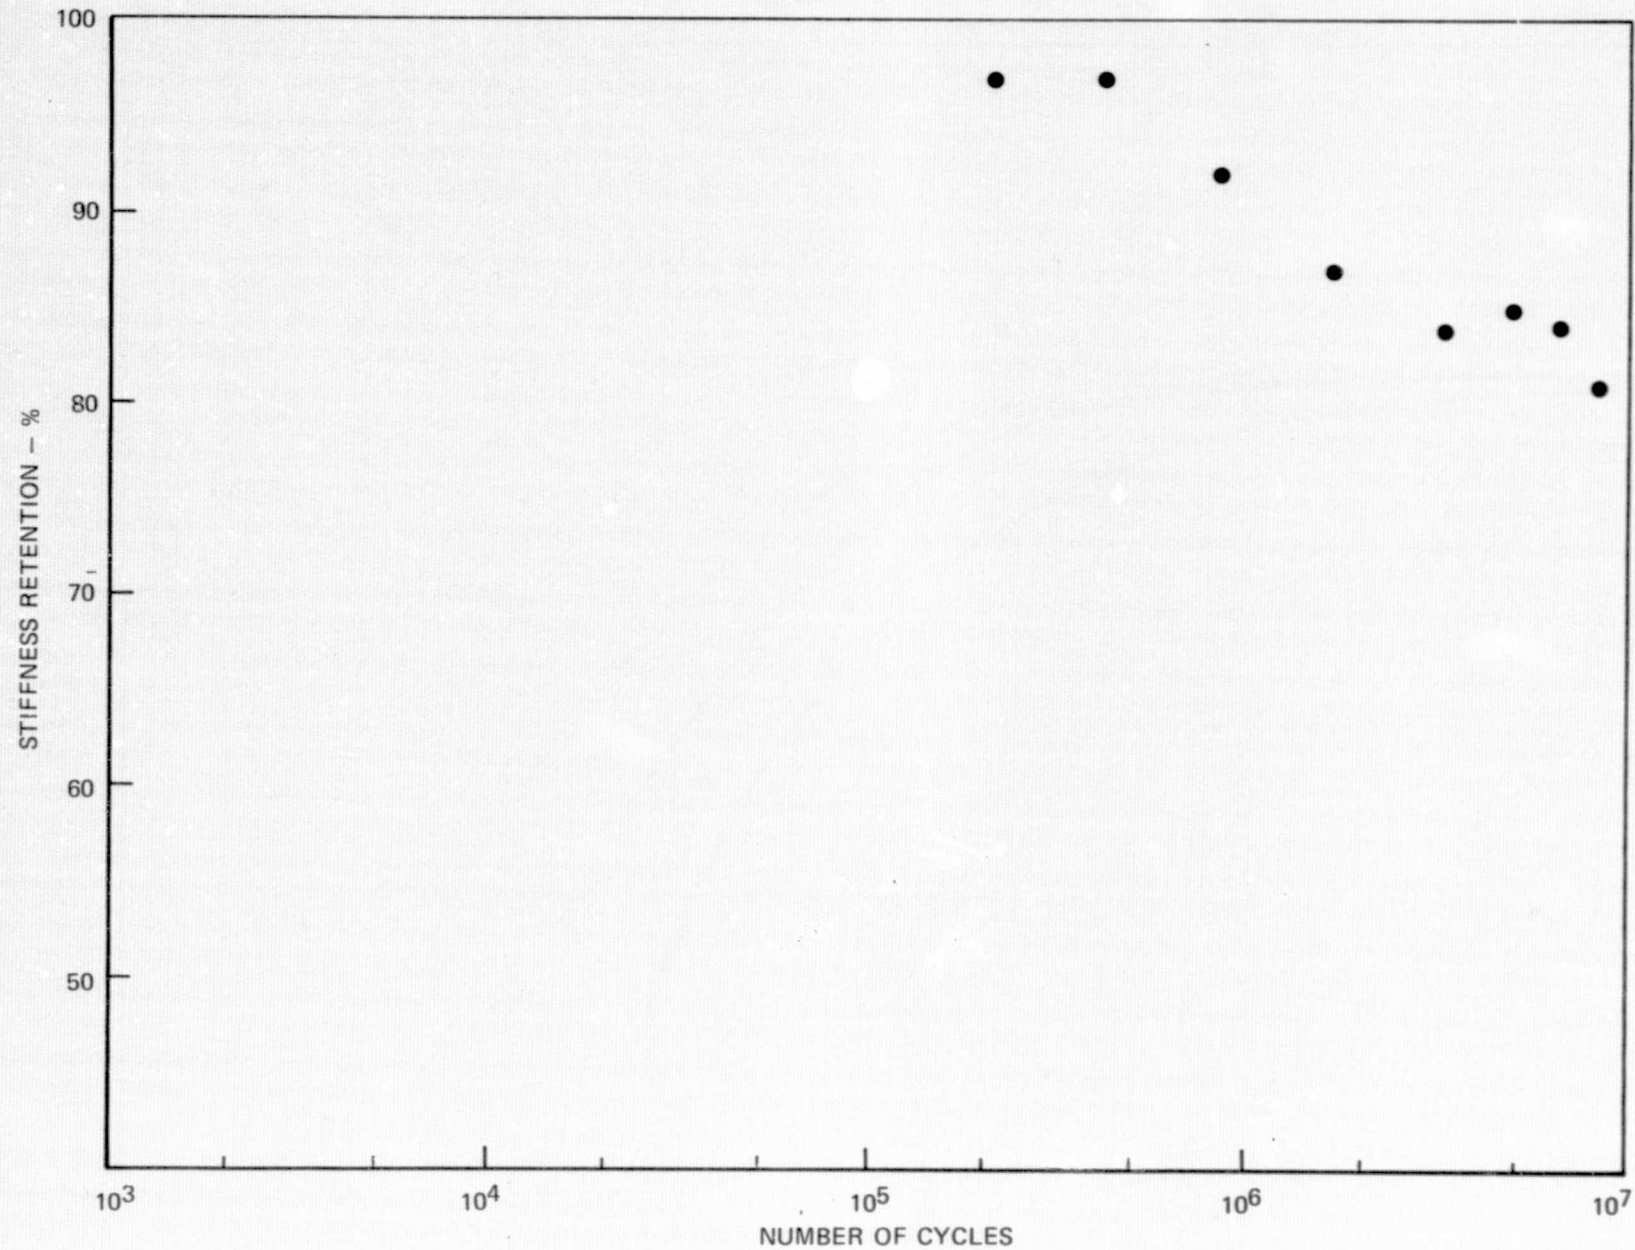
FIG. 27

# TORSIONAL STIFFNESS RETENTION DURING FATIGUE TESTING

SPECIMEN 33-1

ALTERNATING STRESS = 318 MPa (46 ksi)

A typical result is illustrated in Fig. 27 for specimen 33-1 which was subjected to an alternating stress of 318 MPa (46 ksi) for  $10^7$  cycles. Although there was some scatter in the measurements, the torsional rigidity exhibited a steady decrease after approximately  $10^5$  cycles. The stiffness had dropped to 90% of its original value after  $1 \times 10^6$  cycles, and to 80% of its original value after  $1 \times 10^7$  cycles. The loss in stiffness was due to the formation of shear cracks which were frequently visible with the naked eye. The cracks usually

After plotting the data for each specimen as in Fig. 27, the number of cycles for 100%, 90%, and 80% retention of torsional stiffness was determined then compiled into an S-N plot in Fig. 28 for all specimens. The data points are shown for each curve and it is clear that a good deal of scatter existed. Furthermore, the unknown influence of possible stress concentrations during testing caused by the grips leads to the conclusion that the fatigue data must be considered as preliminary. Results more meaningful for the vane application were generated in Task III.

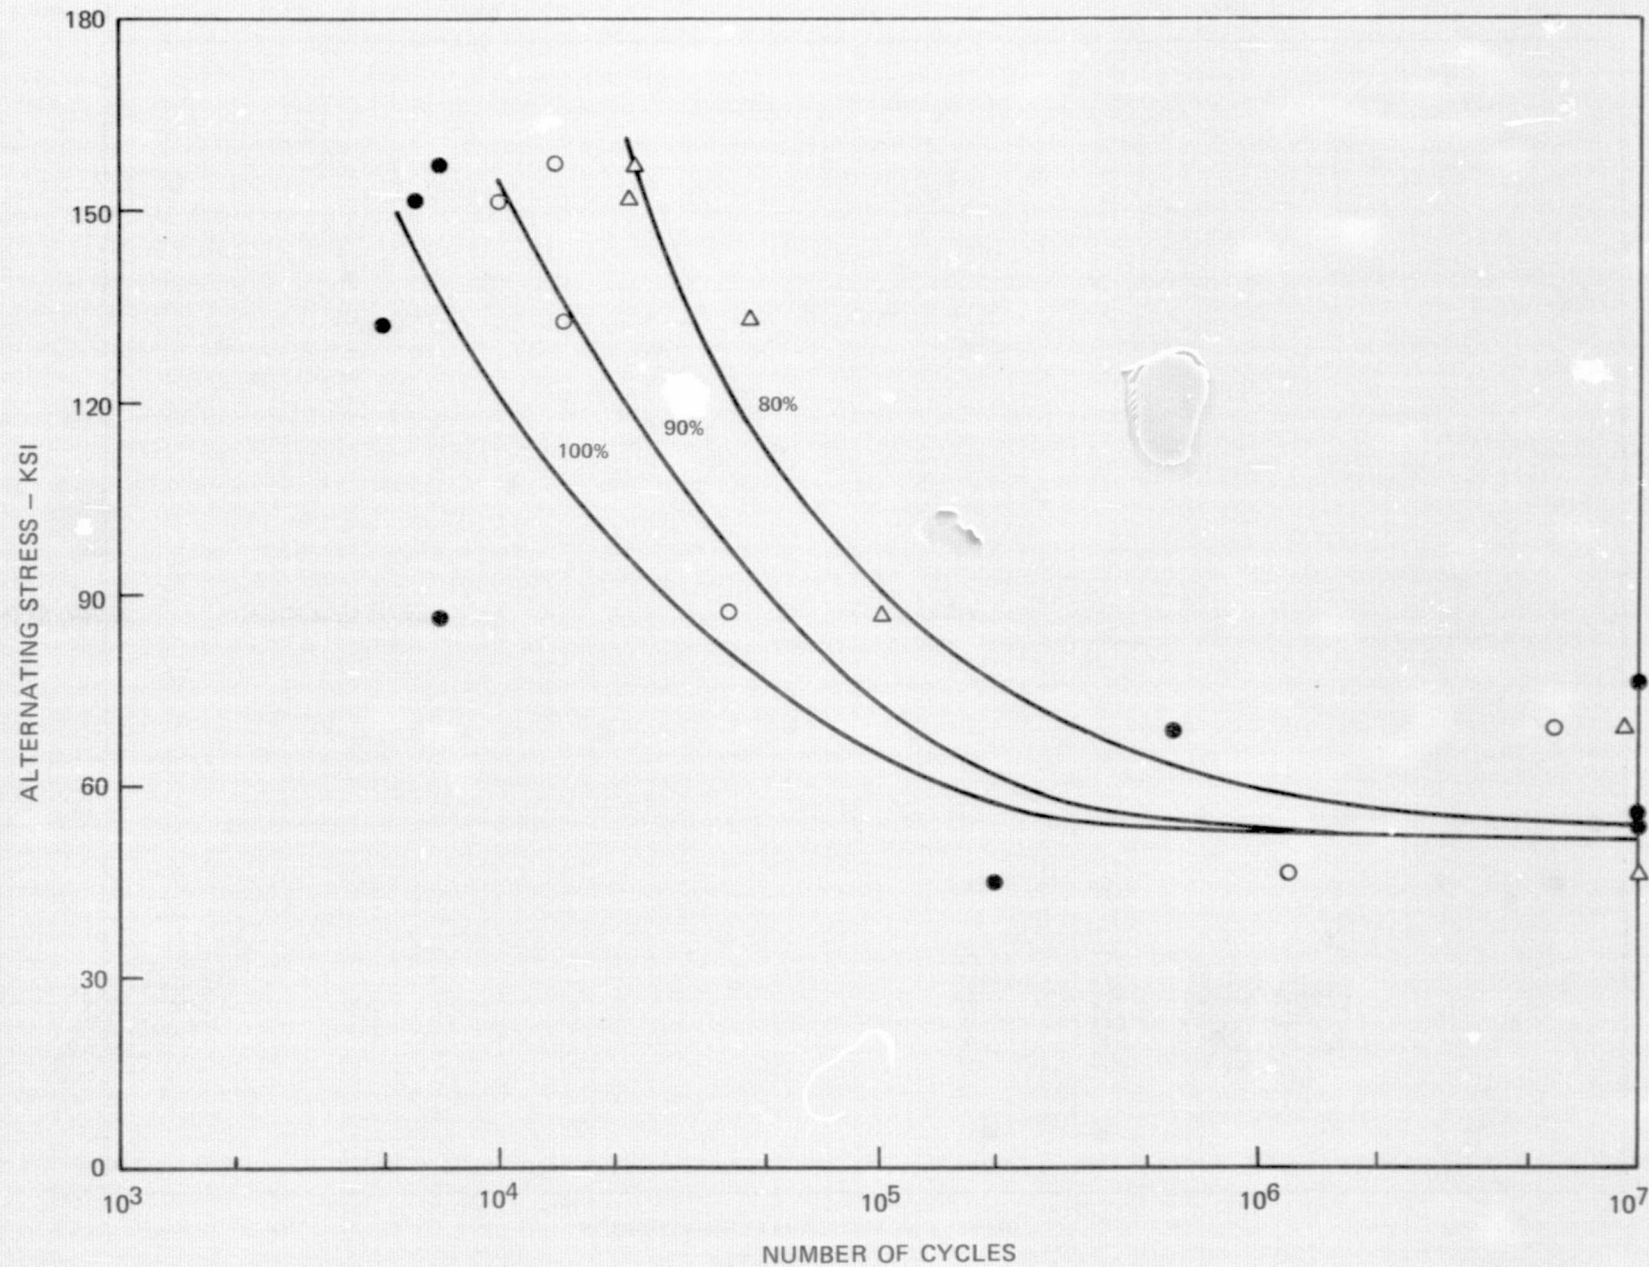
FIG. 28

# TORSIONAL STIFFNESS RETENTION OF UNIDIRECTIONAL FATIGUE SPECIMENS

HMS/300-P POLYTHERSULFONE

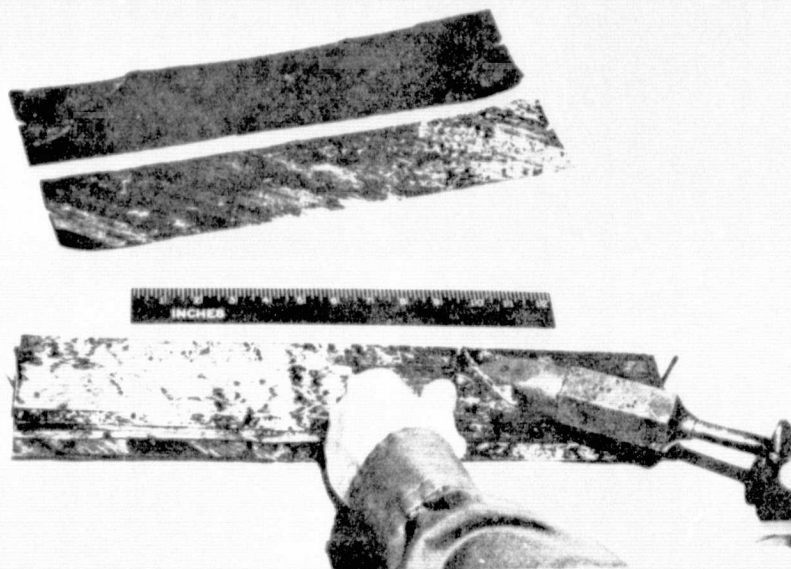
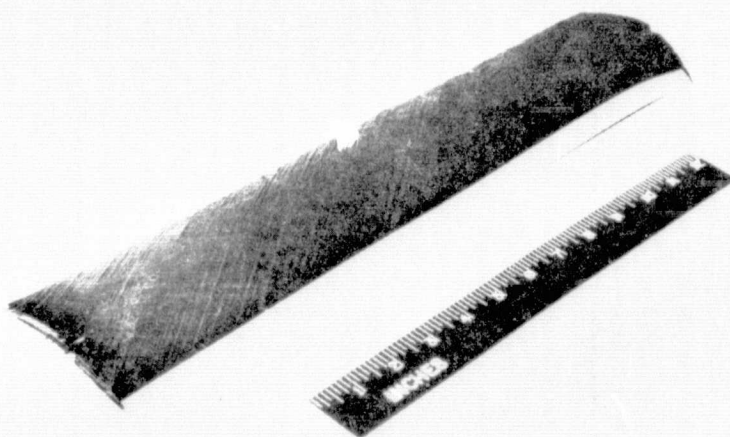
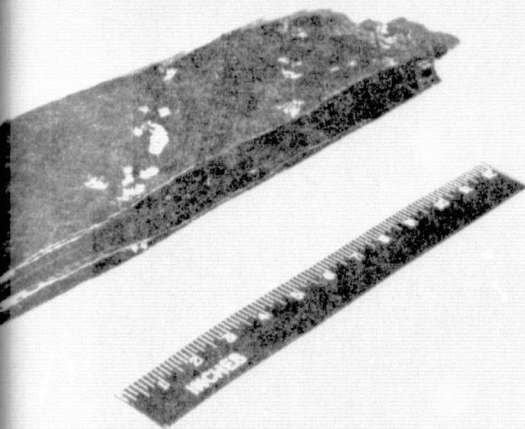
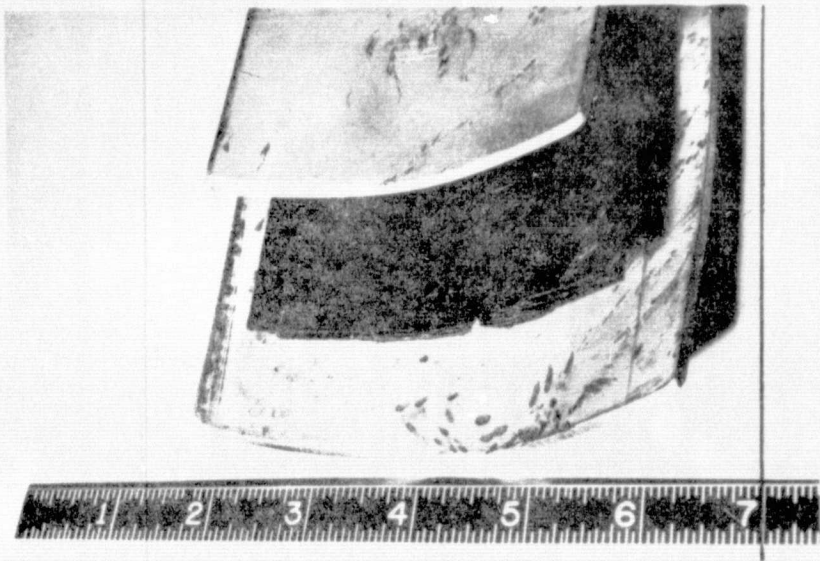
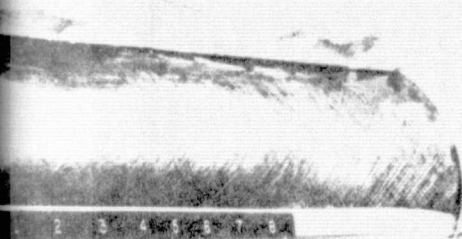
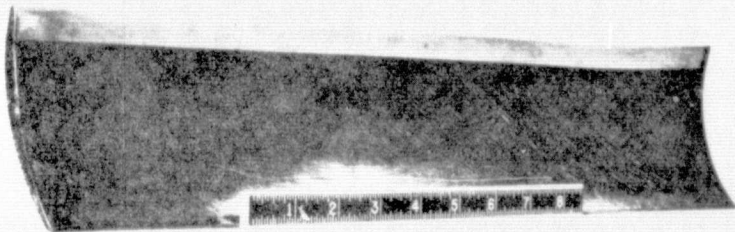
PLY ASSEMBLY

SEQUENCE IN VANE FABRICATION

LAYUP IN PREFORM TOOL

AS-MOLDED VANE

TRIMMED VANE

The sequence of operations in the fabrication of a vane is shown in Fig. 29. The first step shows the package being assembled. Since the prepreg had no tack, the layers were held together by spot heating and locally melting the resin. This technique was found to be more satisfactory than solvent bonding which was much slower and left residual solvent to be removed. The second photograph shows a completed ply package. In order to facilitate handling and to minimize the possibility of misalignment or shifting of the plies, the layup was next subjected to a preforming operation depicted in the third photograph. The plies were inserted between two metal sheets which were bent to a curvature which approximated the camber of the vane. Pressure was applied by clamping, then the assembly was placed in an oven at 285°C for 20 minutes. The fourth picture shows a preformed vane with an aluminum leading strip in position for final molding. The final molding cycle deviated slightly from that used in the previous portions of the program due to limitations of the press used. The intended conditions were 370°C for 60 minutes at a pressure of 13.8 MPa, but the maximum pressure capacity of the press was 8.2 MPa for a part the size of the vane. However, this cycle proved to be completely satisfactory and good flow of the resin was achieved as illustrated in the fifth picture in Fig. 29 which shows both sides of a vane after removal from the mold. After a minor trimming of flash around the edges the finished vane is shown in the final photograph in the figure.

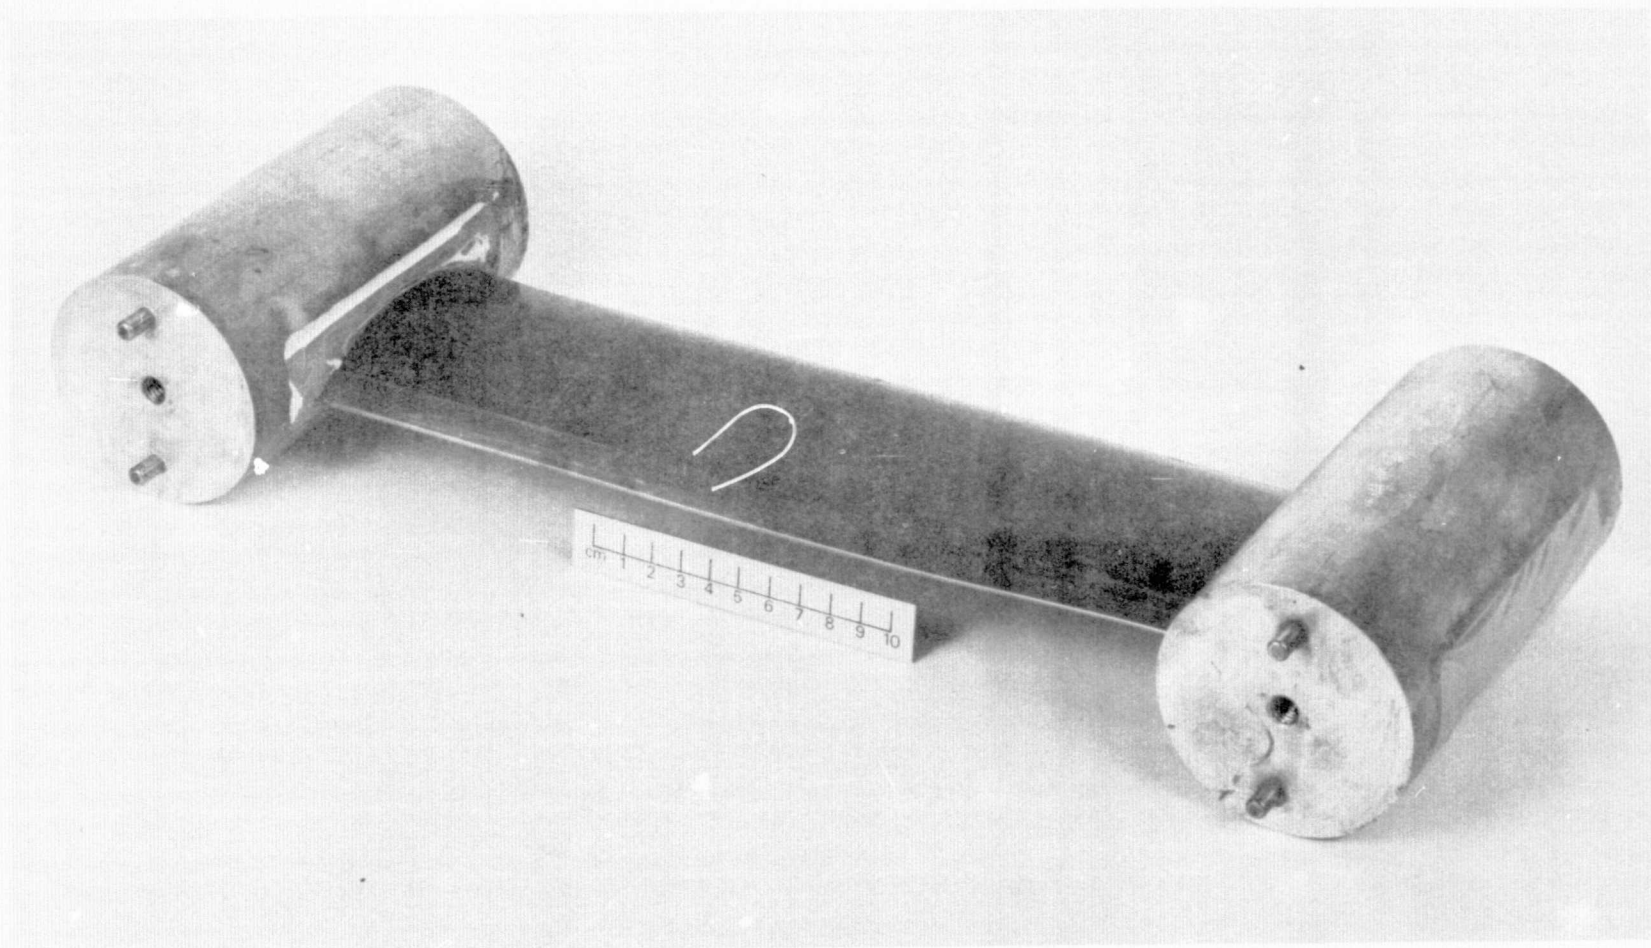
FIG. 30

COMPOSITE VANE WITH RUBBER FEET

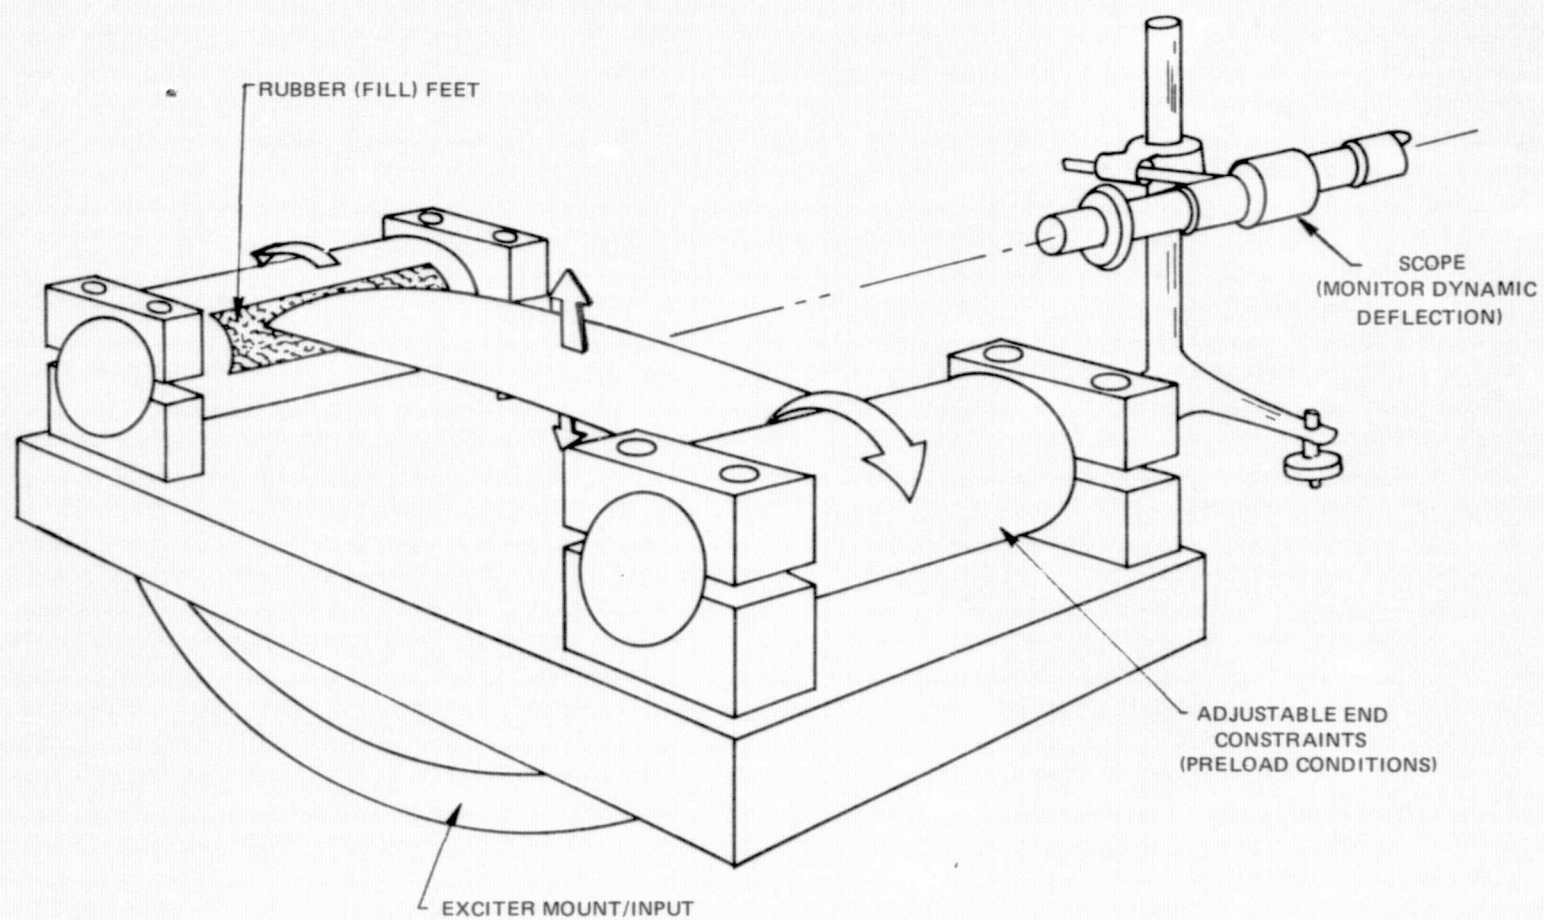
FIG. 31

## FATIGUE TEST FIXTURE- THE FIXTURE SUPPORTS THE VANE AND APPLIES THE STATIC LOAD

Due to the much greater stiffness of the vanes the fatigue conditions were modified in order to produce loads similar to those which would occur in an engine. Table XIV summarizes the fatigue histories of the three vanes which were tested. The previous history of testing vanes indicated that those vanes which could withstand a steady strain of -3000  $\mu\text{in/in}$  (compression)  $\pm$  2400  $\mu\text{in/in}$  in the span-wise direction at midspan on the trailing edge would perform satisfactorily in an engine under the most severe operating conditions. This translated to -1000  $\mu\text{in/in}$   $\pm$  800  $\mu\text{in/in}$  for the stiffer vanes.
